# Titanium Diffusion Hardening (TDH<sup>TM</sup>)

Titanium Slat Track Improvement Project

# Titanium Slat Track Improvement Project

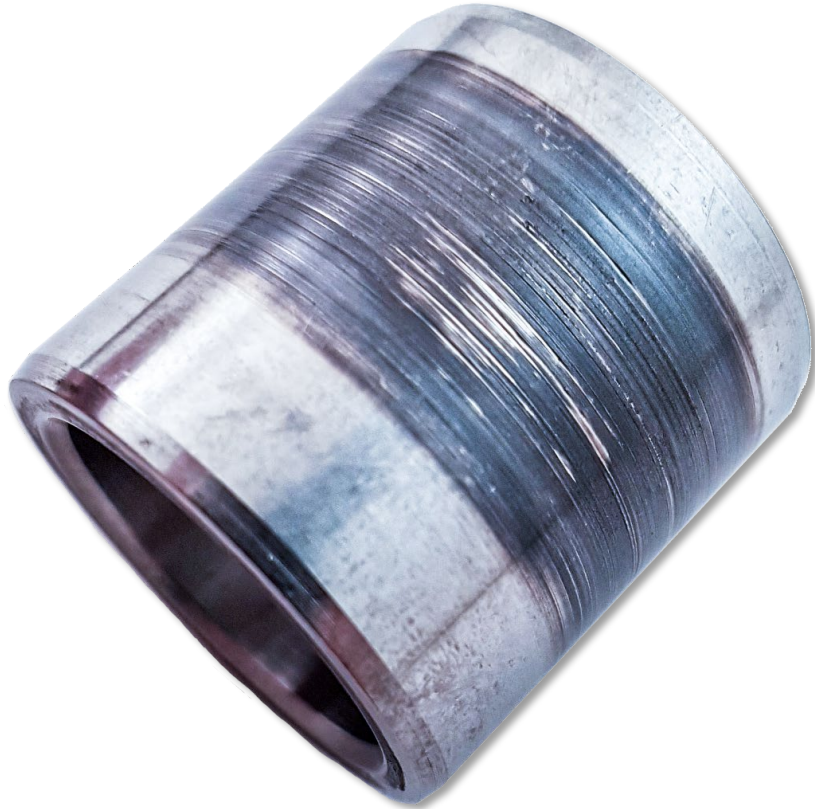
- **Untreated 6Al-4V Titanium (Age Hardened)**
  - Surface scarring present after testing against a polymer-lined journal bearing at high pressure (33ksi, 228 MPa)
- Developed to improve tribological (wear and friction) properties of titanium alloys in self-lube bearings at high loads.
- Titanium operated under very high dynamic bearing loads experiences:
  - Unstable friction characteristics
  - Surface distress
    - ▶ Wear Scarring
    - ▶ Galling

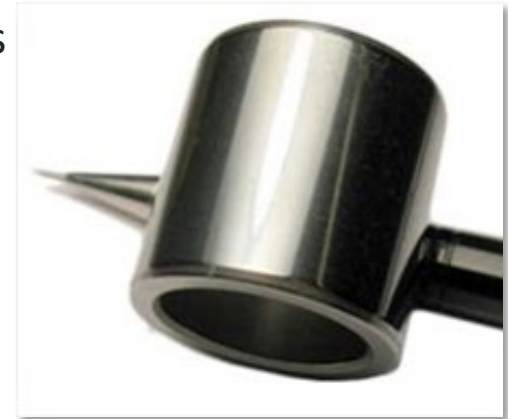
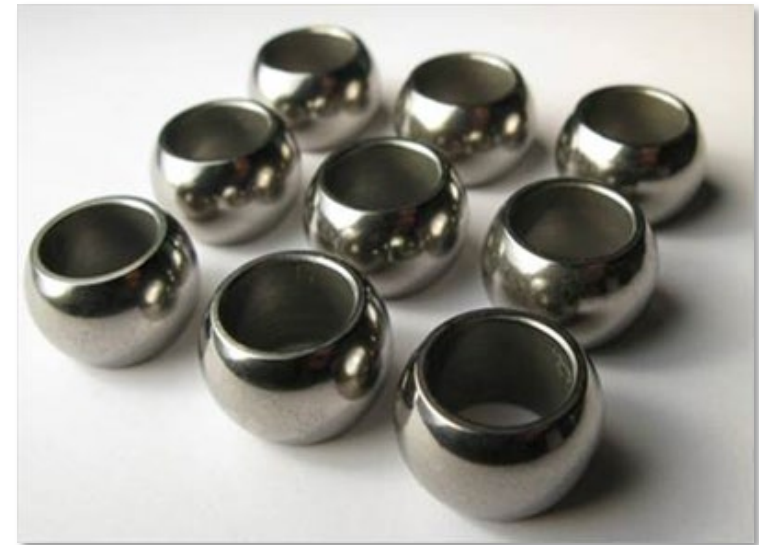
- TDH™ is a unique diffusion-based case hardening process for titanium alloys
  - ▶ Designed to improve the wear & friction properties of titanium alloys in dynamic systems
  - ▶ Thermally-effected in a controlled atmosphere
  - ▶ Not a superficial coating
  - ▶ Hardest at outer surface, gradual hardness transition down to core hardness moving inward
    - $R_c$  60+ hardness at the surface
- No Line-of-Sight processing constraints
- Significant affected case depth (up to .010", 250  $\mu$ m)
- Readily finished to an Ra 4-8  $\mu$ -in finish [0.1 – 0.2  $\mu$ m]

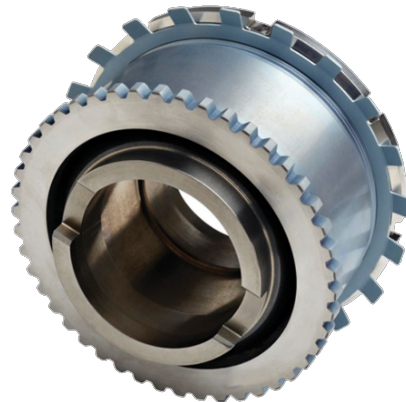
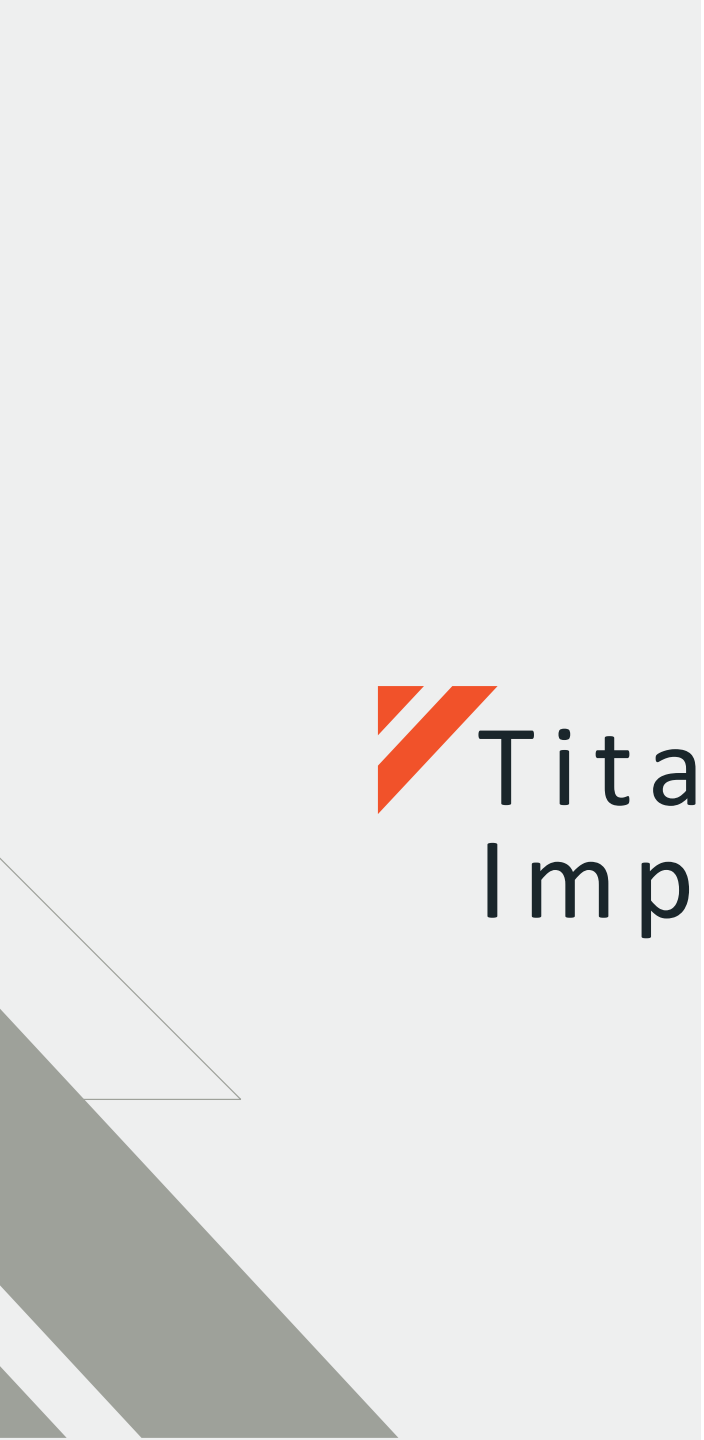
- TDH™-treated 6Al-4V serves as an excellent mating surface for all Karon self-lubricating liners
- Optimal for high-load bearing applications
  - High-hardness interface
  - Deep case depth provides foundation to react high bearing loads
  - Fine surface finish readily achieved (central to lined bearing)
- Case-hardened substrate, not a coating

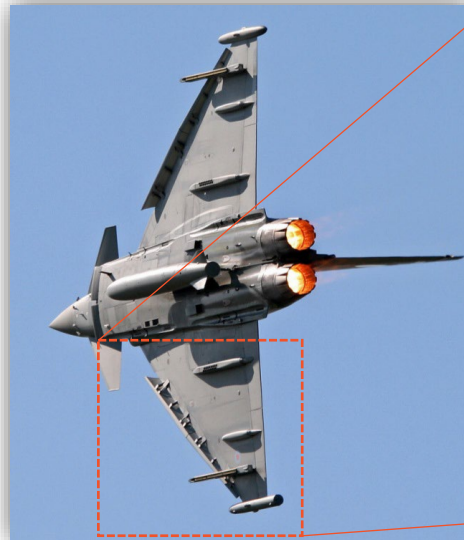
- Military Fixed Wing Aircraft
  - Active slat system
- Slat Actuation – Slat Roller / Track Interface
  - Annealed Titanium (6Al-4V) Track
  - Custom 455 Rollers

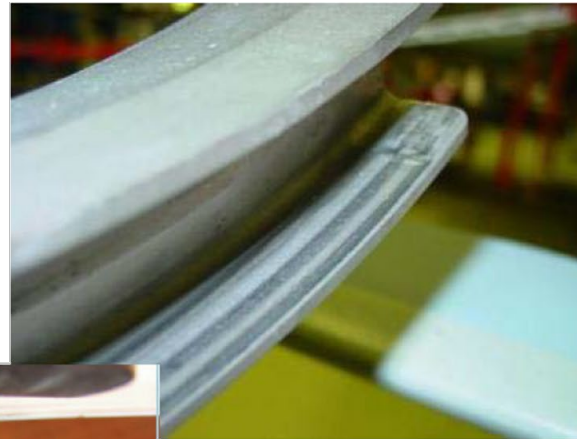
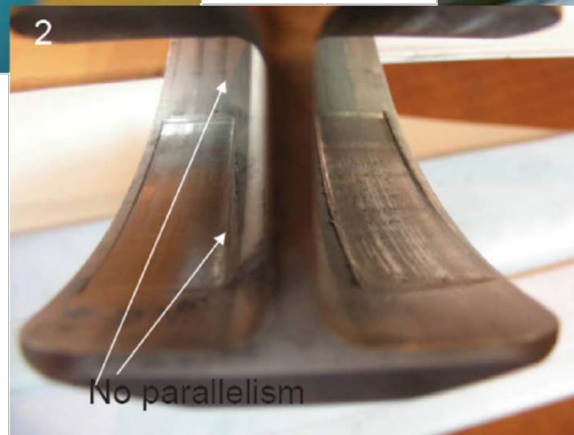
- Titanium tracks experiencing wear in service
- Running surfaces worn to limits (0.6 mm) as early as 400 flight hours

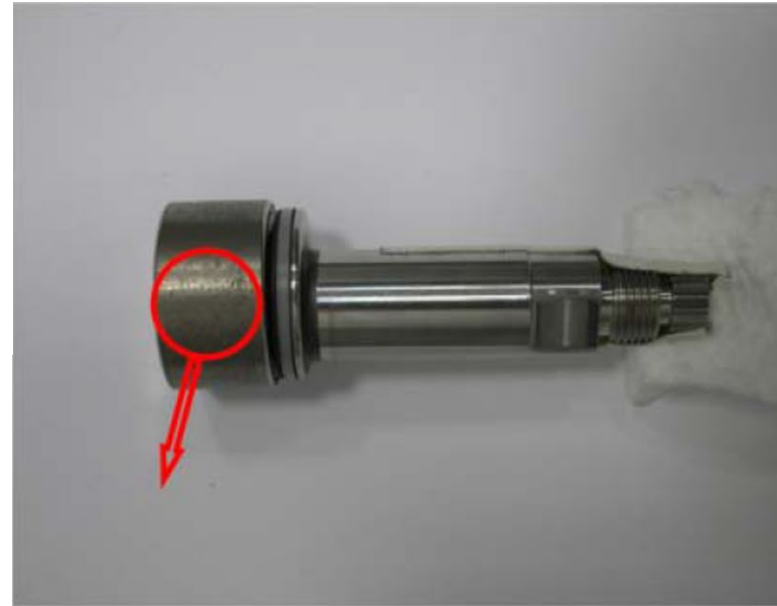
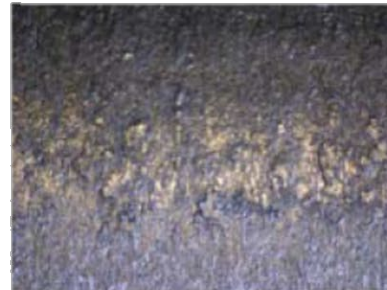
- Adhesive wear condition
- Titanium pickup on roller outer races

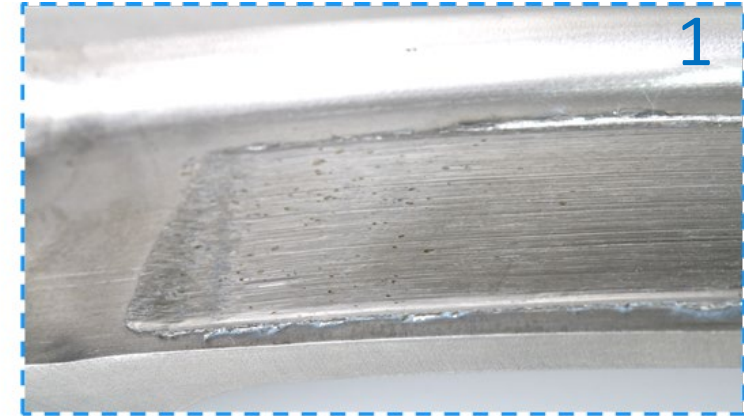
- Current production hardware (Annealed 6Al-4V Titanium Track)
- Test stopped after **600** test hours, wear limit reached
  - 0.8 mm wear depth, heavy scarring

- TDH-treated track successfully demonstrated full endurance life requirement through bench test program
  - ▶ **Annealed** baseline track worn to limits at **600 hours**
  - ▶ Hardcoat solution discontinued at 5,400 SFH test hours, roller contact wear issues
  - ▶ **TDH** track successfully completes **6,000 hours** with no measurable wear
- TDH registers an improvement of more than 30x in specific wear rate when compared with current annealed configuration track and eliminates roller wear

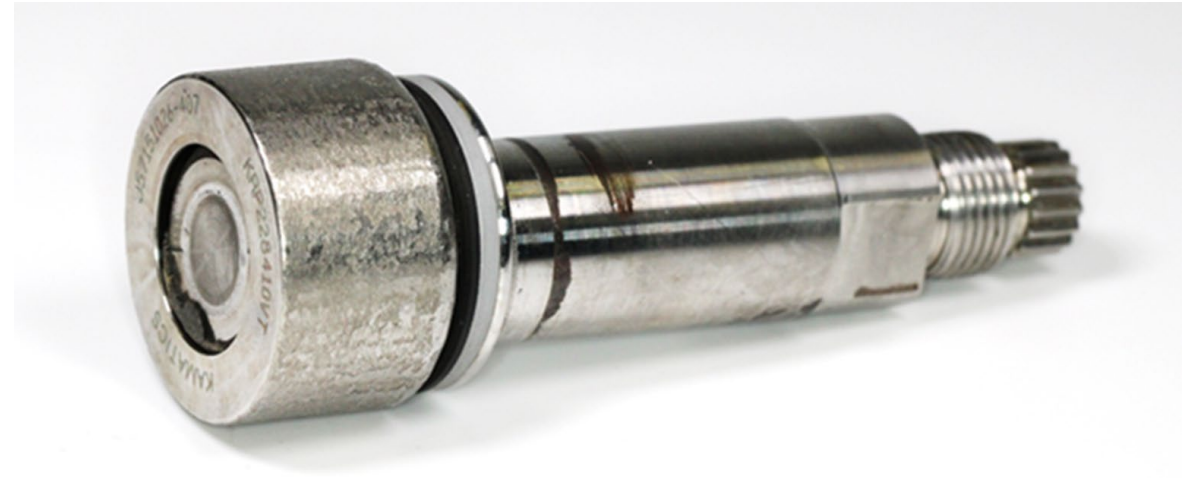
- Track roller bearing mated with Annealed Track (600 Hours)
- Heavy distress, adhesive wear (titanium pick-up)

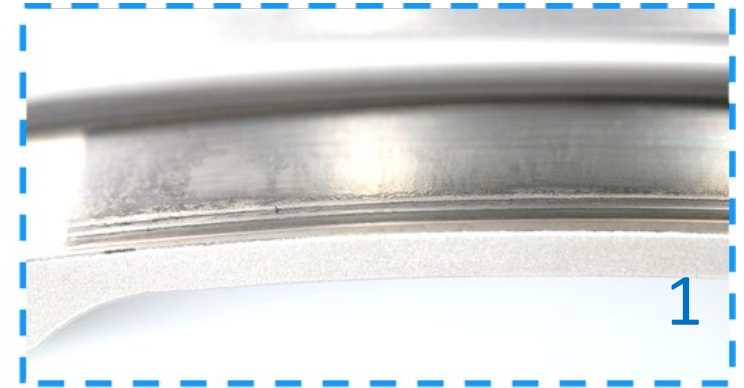
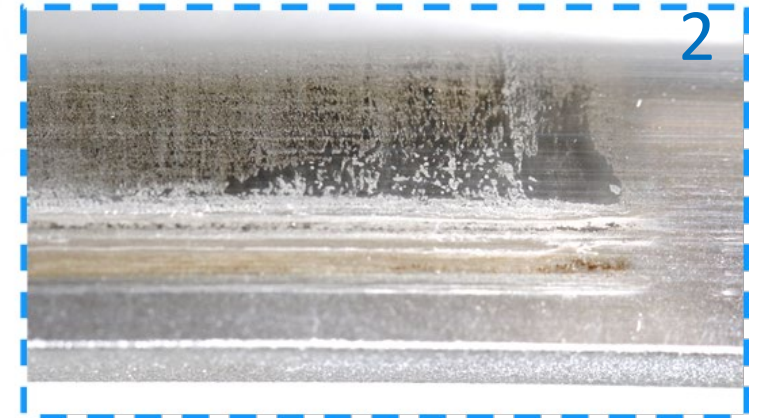
- TDH-treated test track
- Test successfully completed full **6,000** hours
- Slight surface roughening in one location, no measurable wear to running surfaces

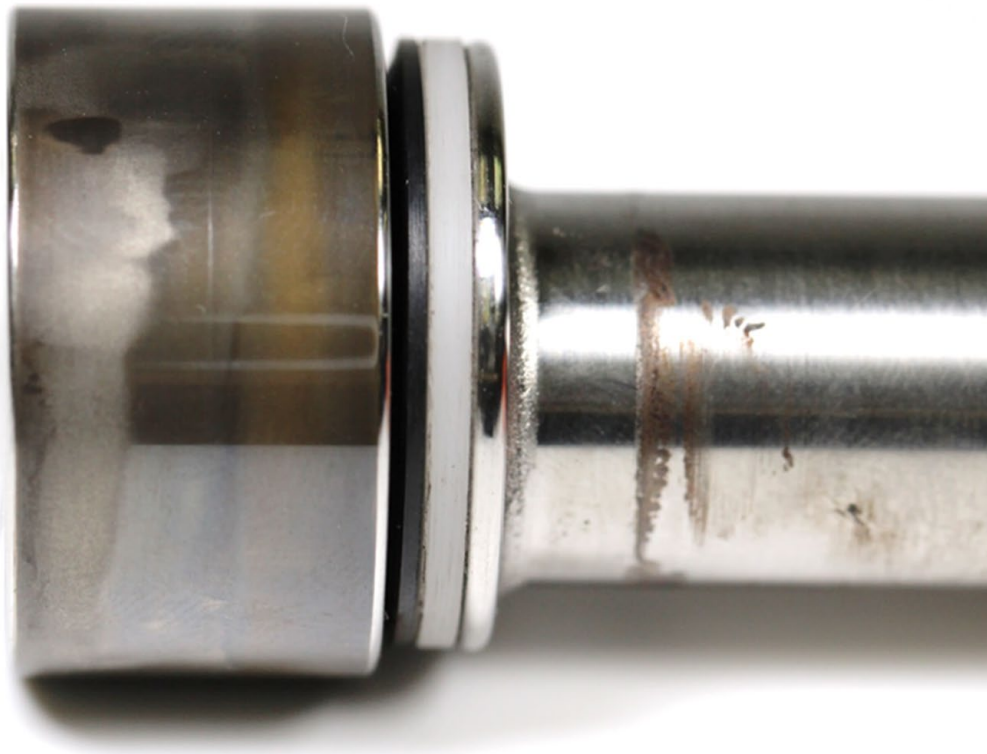
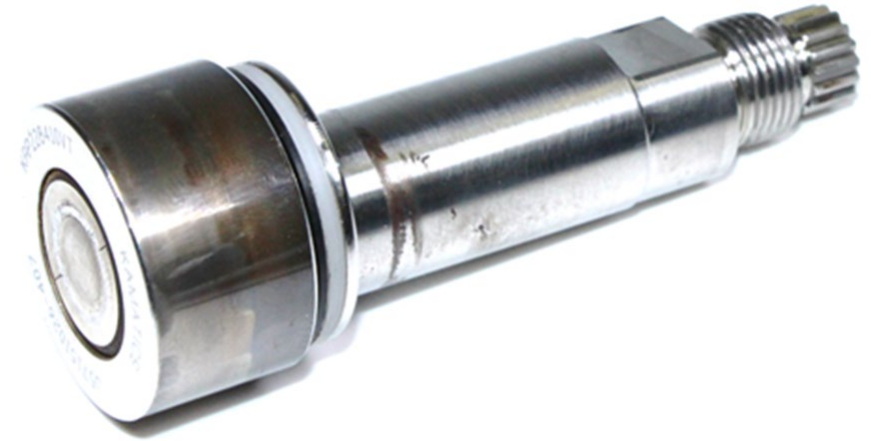
- Track roller bearing mated against TDH-treated Track (6000 Hours)
- OD burnishing, no measurable wear
