Service Instruction Number SIN3052 Revision D

Installation, Maintenance, and Repair of the KAflex® Driveshaft for the Bell 206 LI/LIII LongRanger

Installation, maintenance and repair of the KAflex® Driveshaft for the Bell Models 206 L1 and 206 L3 Helicopters.

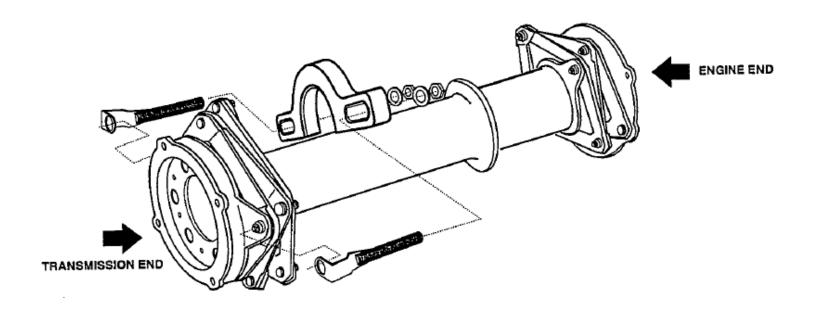
Use ½" deep socket or wrench to compress Flex Frames just enough to install driveshaft. Compress driveshaft only enough to allow installation.

- a. Inspect firewall gasket bonded to firewall. Repair as necessary per BHT Maintenance Manual. Install the SKCP3054-5 lower firewall cover as shown on the installation Drawing SKCP3052 and Figure 1.
- b. Install the SKSP1404 installation tool on the transmission end of the driveshaft per Figure 2. Compress the KAflex Flex Frames just enough to install the driveshaft by tightening the nuts evenly with a deep socket.
- c. Insert driveshaft end with small diameter flex frames into opening in the firewall cover so that the end with the larger flex frames rests against the upper right part of the main transmission.
- d. Move the driveshaft into position and engage pilot. With the driveshaft correctly positioned between the engine and transmission flanges, remove the installation tool.
- e. Install mounting hardware per assembly Drawing SKCP3052.

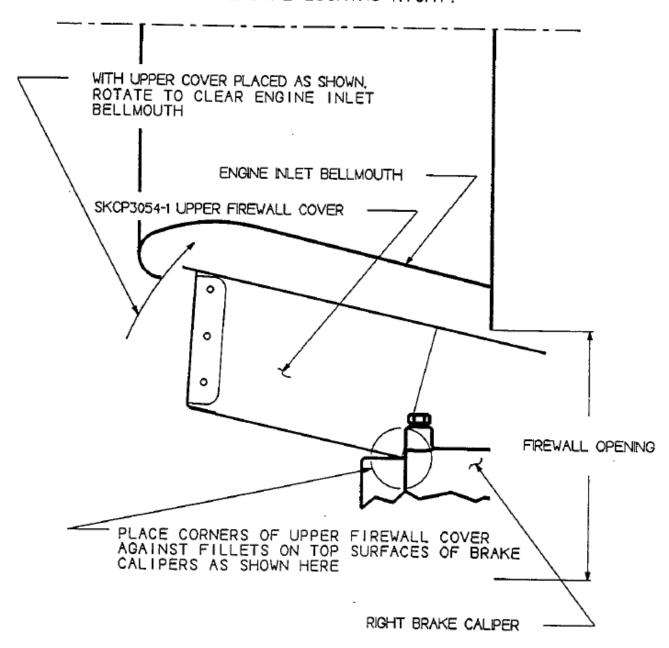
FIGURE 3: Location of Upper Firewall for ease of installation with Rotor Brake

VIEW FROM AIRCRAFT CENTERLINE LOOKING RIGHT:

f. Install the SKCP3054-5 upper firewall cover as shown on the Installation Drawing SKCP3052 and Figure 1. The upper cover assembly is most easily installed by positioning it as shown in Figure 3 if the aircraft is equipped with a rotor brake. If no rotor brake is installed, a special technique is not necessary for installation.

- 5. Modification of Master Cylinder (Continued)
 - e. Install the SKCP3054 Top Access Panel Assembly per Figure 1 and SKCP3053. The upper cover assembly is most easily installed by positioning it as shown in Figure 3. Verify that the AN3-3A bolts on the sides of the Top Access Panel do not contact the brake hoses.

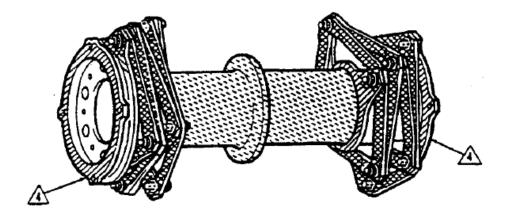
FIGURE 6: Damage Limits – KAflex Driveshaft

Type of Damage	Maximum Damage and Repair Depth							
MECHANICAL	0.001" before and after repair	0.005" before and after repair	0.005" before and after repair	0.015" before and after repair				
CORROSION	Surface, no pits	0.005" before and after repair	0.005" before and after repair	0.010" before and after repair				
MAXIMUM AREA PER FULL DEPTH REPAIR SQ. IN.	0.05 in ²	0.10 in ²	0.25 in ²	0.25 in ²				
NUMBER OF REPAIRS	One per leg							
EDGE DENTS, NICKS	0.001 in	0.010 in	0.010 in	0.025 in

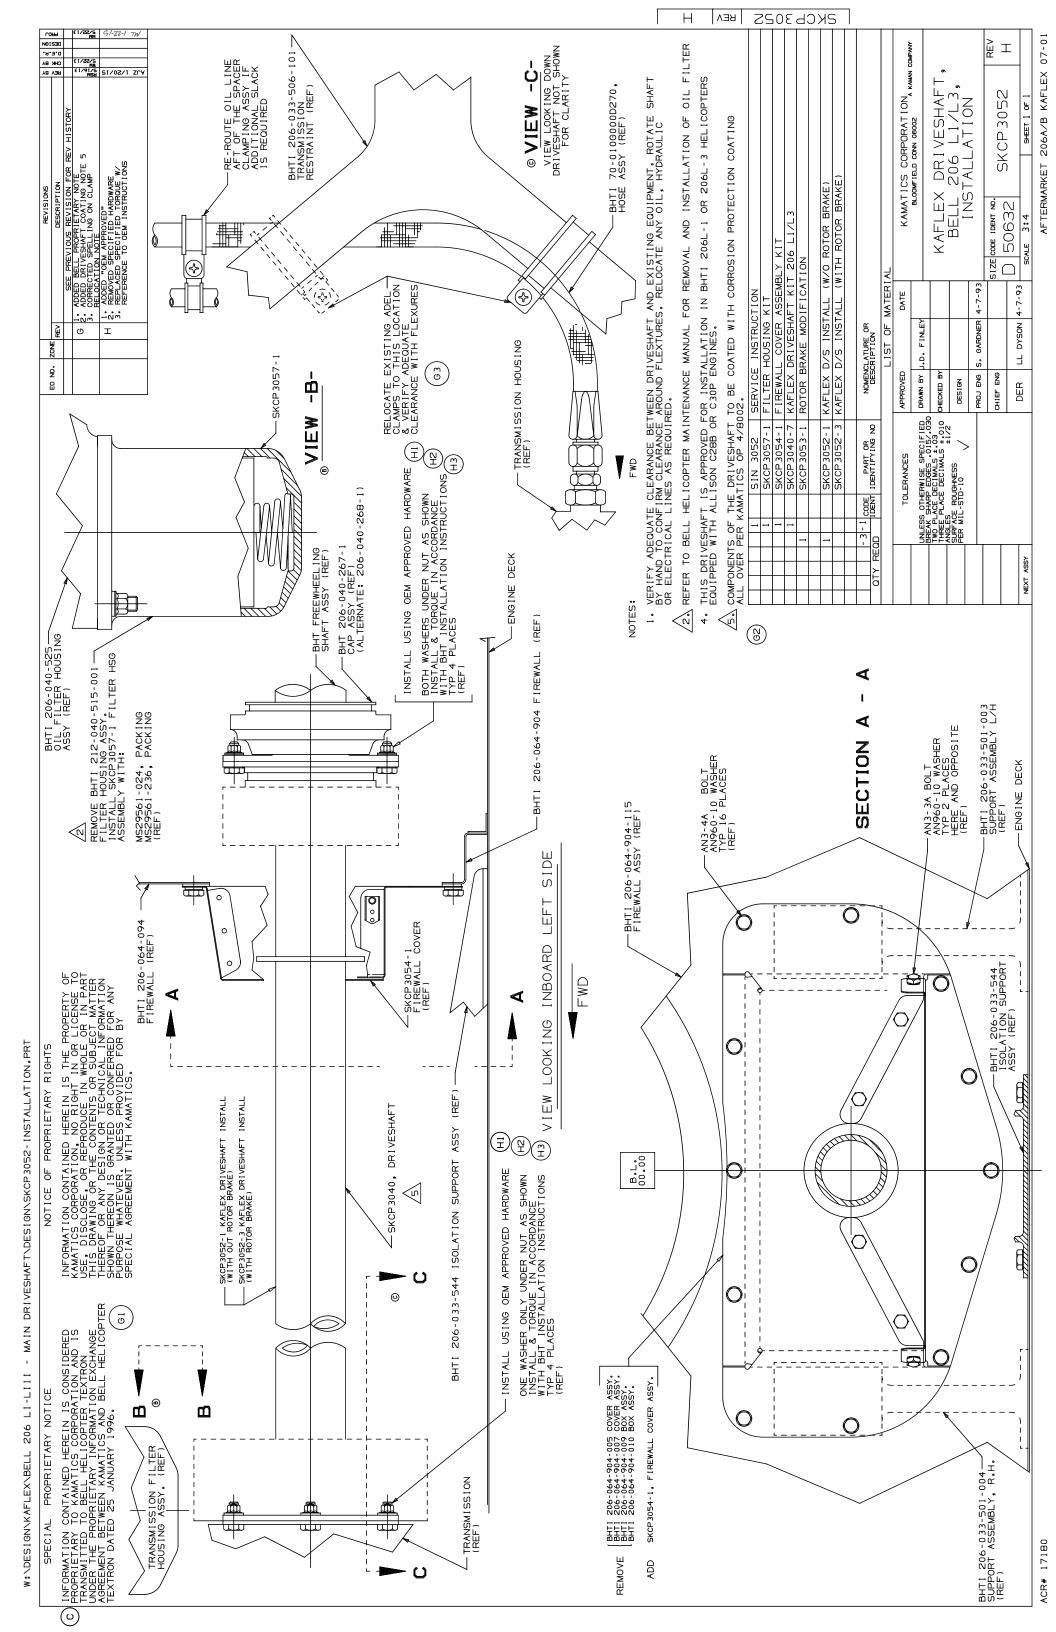
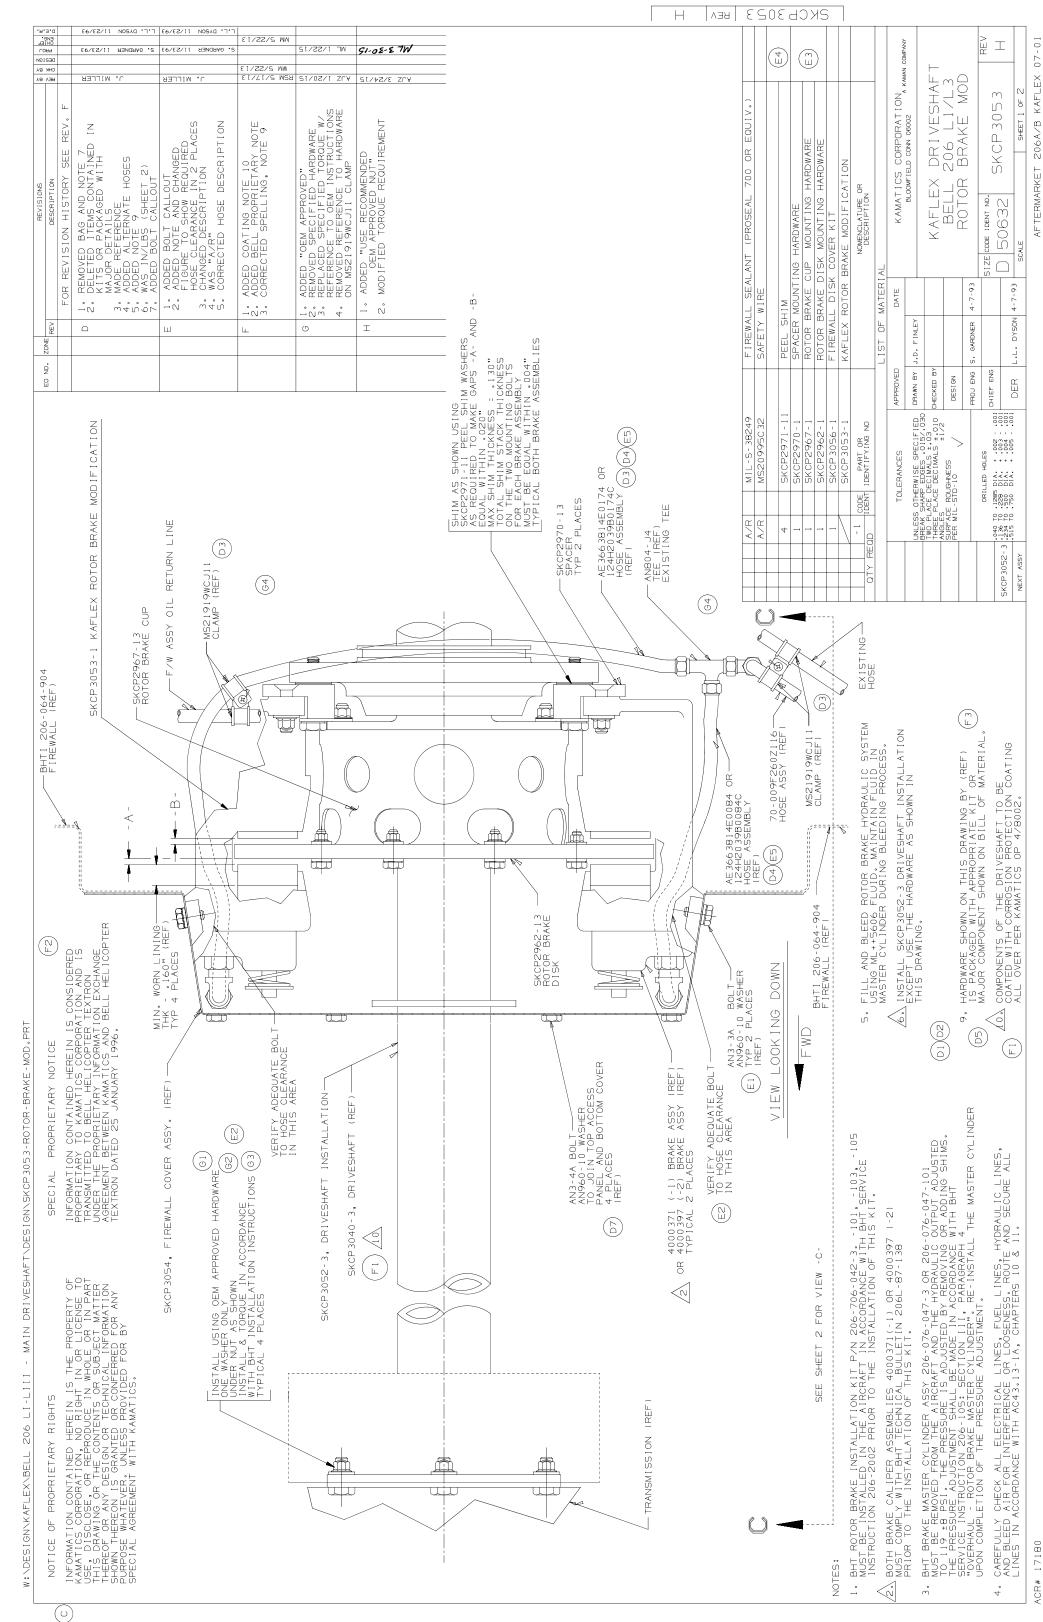
SKCP3052 SH 1 SKCP3053 SH 1, 2

Following are copies of each of two pages of the Installation Drawing for STC SH8683SW.
