# Service Instruction Number SIN3587 Revision C

Installation, Maintenance and Repair of the KAflex® Driveshaft for the Bell 212 and 412 (Standard & SP) Helicopters.

#### **KAMATICS CORPORATION SERVICE INSTRUCTION NUMBER 3587**

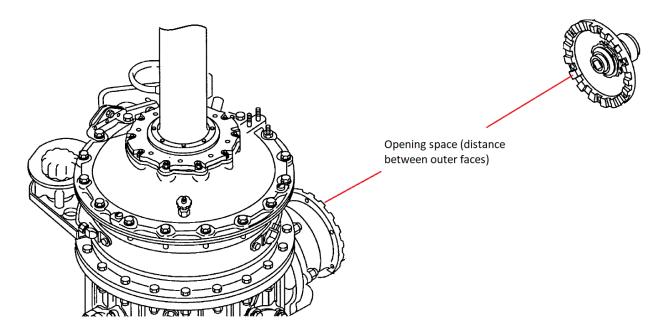
Figure 1, Opening Dimension Reference

a. Measure the distance between the adapter face (Figure 2, item 7) and the input drive quill face (Figure 2, item 11). The distance must be 47.480 to 47.780 inches. If the distance is not met, adjust per the Bell maintenance manual chapter 71 section 7. See Figure 1 for additional reference.

- a. Measure the distance between the adapter face (Figure 2, item 7) and the input drive quill face (Figure 2, item 11). The distance must be 47.480 to 47.780 inches. If the distance is not met, adjust per the Bell maintenance manual. See Figure 1 for additional reference.

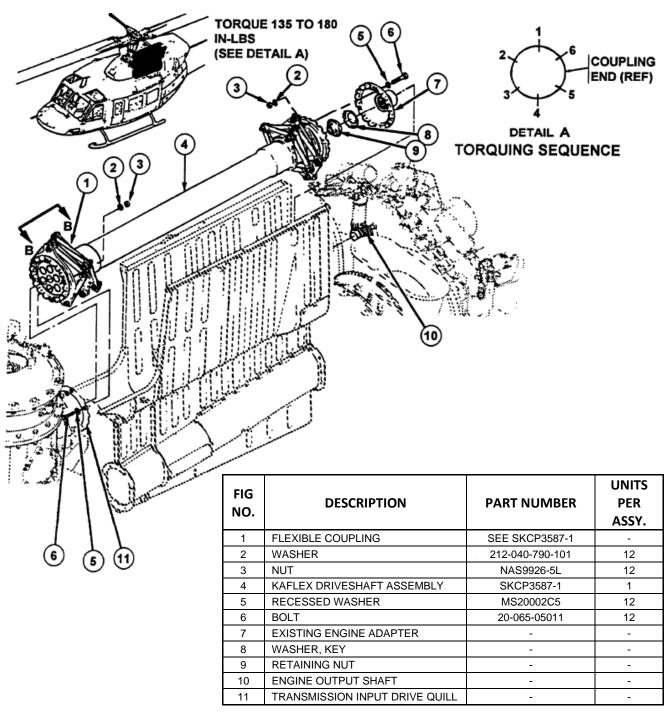
Figure 2, Installation/Removal

- b. Move the driveshaft into position between adapter face (Figure 2, item 7) and the input drive quill face (Figure 2, item 11).
  - i. Caution: Do not compress ends of driveshaft beyond 0.400". This will prevent damage.

- c. Install hardware using Figure 2 with the associated figure numbers. Install recessed washers (5) on bolts (6) chamfer side to bolt-head. Install bolts (6) from existing engine adapter (7)/transmission input drive quill (11) side. Install washers (2) and nuts (3) on bolts (6) against flexible couplings (1). Nut torques shall be accomplished in three steps: one-third torque, two thirds torque, and full torque respectively. Torque nuts (3) in sequence 1, 3, 5, 6, 2, 4. See Detail A in Figure 2. Repeat sequence at each torque step. Full torque is 135 to 180 inch-pounds. Apply a torque stripe, using a "Skydrol" resistant torque stripe (tamper-proof mark), across the nut (3), washer (2) and end fitting of the flexible coupling (1). Similarly apply a torque stripe across the bolt (6), washer (5) and the mounting point [Transmission input quill (11) or Existing engine adapter (7)]. Do not re-use previous mounting hardware.

- a. Disconnect battery.
- b. Remove inlet fairings and engine top cowling to gain access to the main driveshaft per the BHT Maintenance Manual
- c. Remove mounting hardware (Figure 2, items 2, 3, 5 and 6). Mounting hardware, excluding nuts, may be reused in accordance with best maintenance practices. Self-locking nuts must be replaced with new units each time the shaft is removed from the aircraft.
  - Caution: The driveshaft must be supported at either end during installation. Loose bolts at the 12 o'clock position may be used to support the shaft.

- b. Move the driveshaft into position between adapter face (Figure 2, item 7) and the input drive quill face (Figure 2, item 11).
  - i. Caution: Do not compress ends of driveshaft beyond 0.400". This will prevent damage.

- c. Install hardware using Figure 2 with the associated figure numbers. Install recessed washers (5) on bolts (6) chamfer side to bolt-head. Install bolts (6) from existing engine adapter (7)/transmission input drive quill (11) side. Install washers (2) and nuts (3) on bolts (6) against flexible couplings (1). Nut torques shall be accomplished in three steps: one-third torque, two thirds torque, and full torque respectively. Torque nuts (3) in sequence 1, 3, 5, 6, 2, 4. See Detail A in Figure 2. Repeat sequence at each torque step. Full torque is 135 to 180 inch-pounds. Apply a torque stripe, using a "Skydrol" resistant torque stripe (tamper-proof mark), across the nut (3), washer (2) and end fitting of the flexible coupling (1). Similarly apply a torque stripe across the bolt (6), washer (5) and the mounting point [Transmission input quill (11) or Existing engine adapter (7)]. (Figure 2, items 2, 3, 5 and 6). Mounting hardware, excluding nuts, may be reused in accordance with best maintenance practices. Self-locking nuts must be replaced with new units each time the shaft is removed from the aircraft.

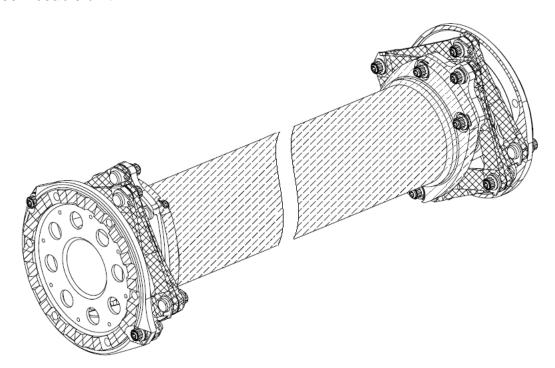
Figure 3, Damage and Repair Limits

- 1. Refer to Figure 3 for repair criteria. All blends shall be smooth at maximum depth and smoothly blended with surrounding surfaces.
- 2. The KAflex Driveshaft is not field overhauled. Disassembly of the KAflex driveshaft will render it unserviceable.
- 3. The KAflex Driveshaft is to be removed at 5,000 hours and replaced with a serviceable unit.

Type of Damage	Maximum Damage and Repair Depth						
AREA							
MECHANICAL	0.001" before and	0.012" before and	1	0.015" before and			
	after repair	after repair		after repair			
CORROSION	Surface, no pits	0.012" before and after repair	2	0.010" before and after repair			
MAXIMUM AREA PER FULL DEPTH REPAIR SQ. IN.	0.05 in <sup>2</sup>	0.09 in <sup>2</sup>	0.25 in <sup>2</sup>	0.25 in <sup>2</sup>			
NUMBER OF REPAIRS	One per leg	10	3	One per 1 in <sup>2</sup>			
EDGE DENTS, NICKS	0.001 in	7	0.005 in	0.025 in			
CRACKS	None	None	None	None

- d. Inspect KAflex Driveshaft for damage and corrosion. Refer to Figure 3 (in Section 5) for damage and repair limits.
- e. Inspect KAflex Driveshaft flex frame joints for fretting dust which will appear as red metallic residue. If grease, oil or dirt is covering suspected area, or any doubt exists as to whether actual fretting has occurred, clean suspected areas thoroughly and recheck in conjunction with next daily inspection.
  - If fretting is apparent, replace unit with a serviceable unit.
- f. Inspect KAflex Driveshaft for signs of contact, rubbing, and/or chafing.
