KAM-3587-ICA-001 Revision B

Instructions for Continued Airworthiness of the KAflex® Main Rotor Driveshaft for the Bell 212 and 412 (Standard and SP) Helicopters

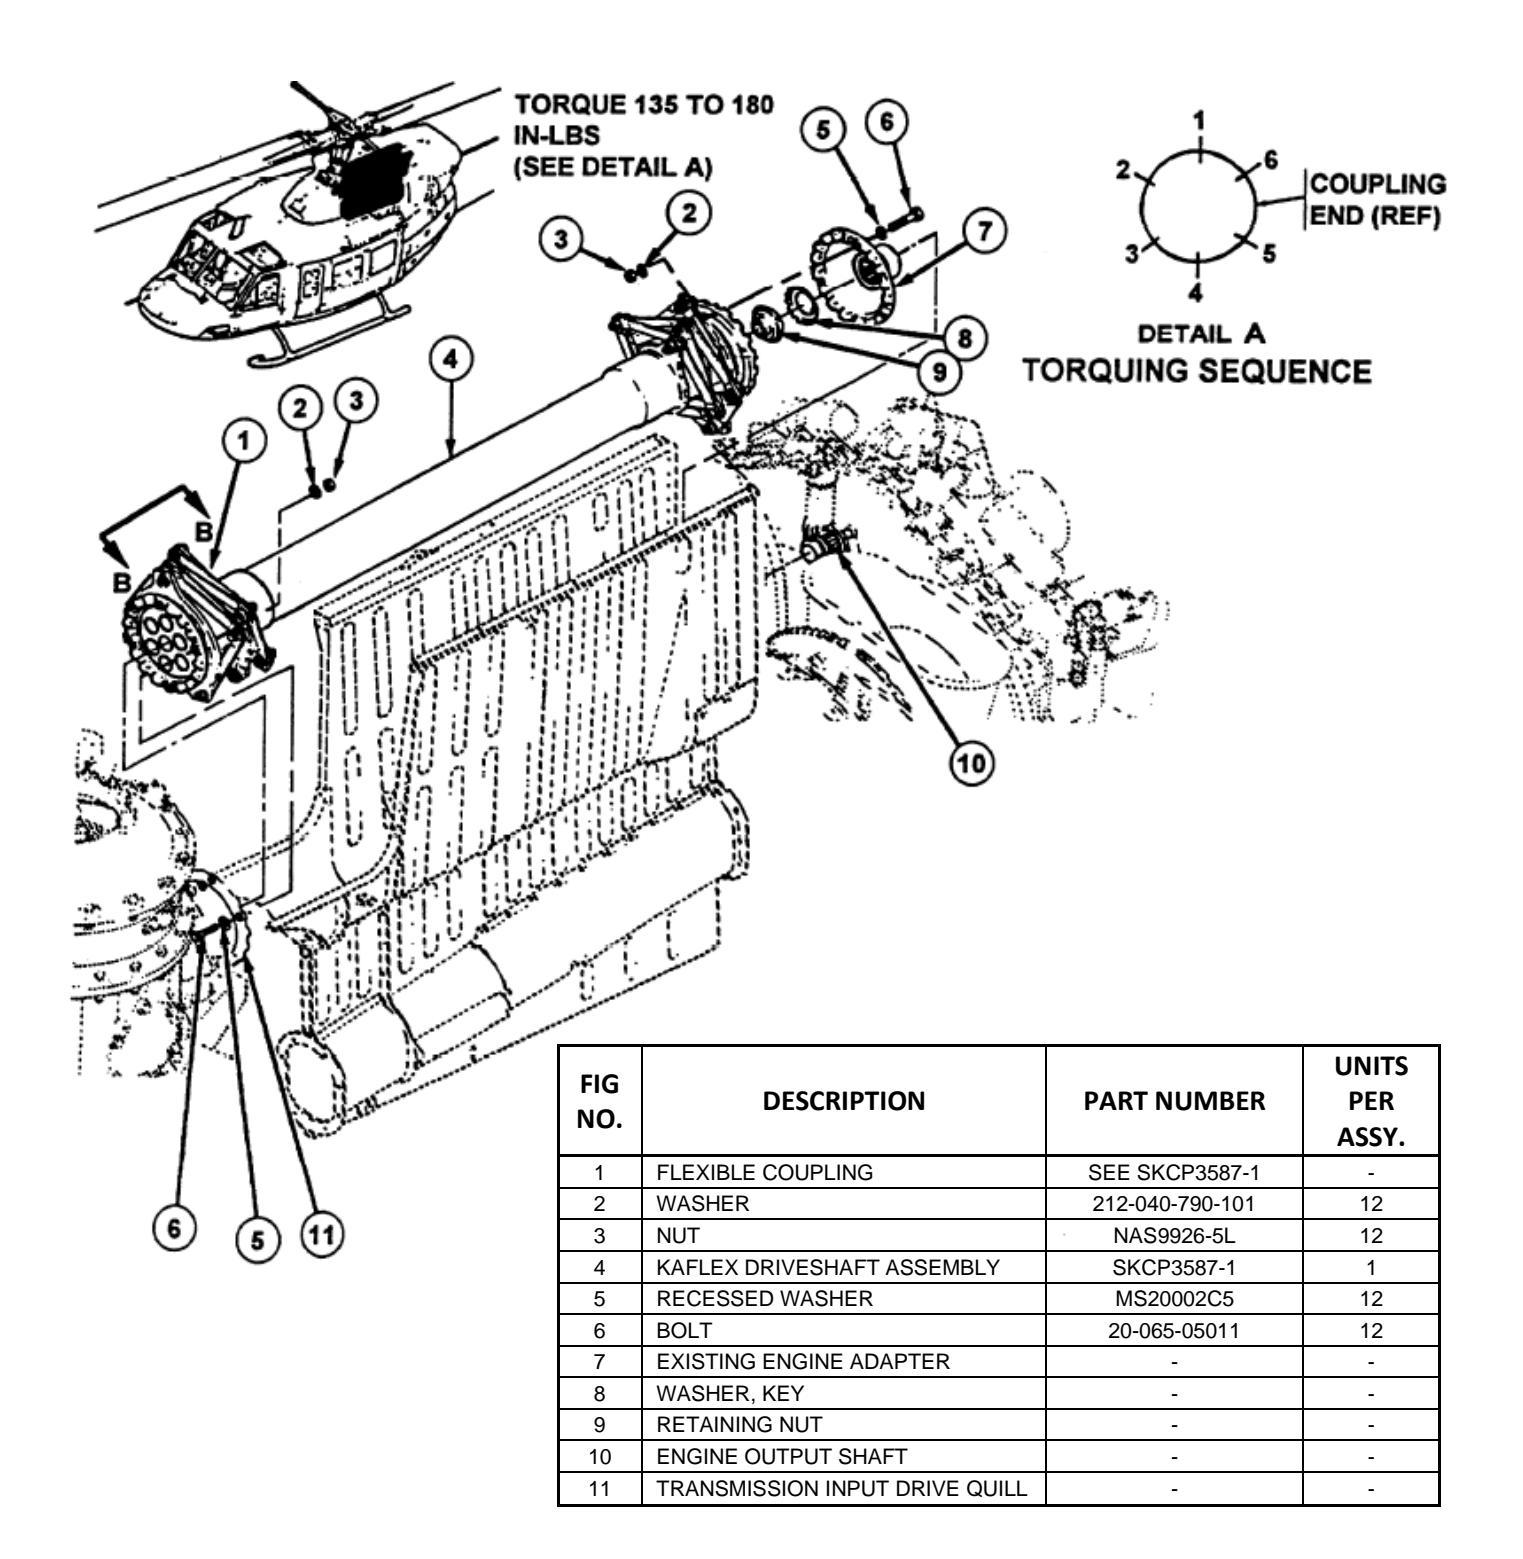
Figure 1, Installation/Removal

- c. Install hardware using Figure 1 with the associated figure numbers. Install recessed washers (5) on bolts (6) chamfer side to bolt-head. Install bolts (6) from existing engine adapter (7)/transmission input drive quill (11) side. Install washers (2) and nuts (3) on bolts (6) against flexible couplings (1). Nut torques shall be accomplished in three steps: one-third torque, two thirds torque, and full torque respectively. Torque nuts (3) in sequence 1, 3, 5, 6, 2, 4. See Detail A in Figure 1. Repeat sequence at each torque step. Full torque is 135 to 180 inch-pounds. Apply a torque stripe, using a "Skydrol" resistant torque stripe (tamper-proof mark), across the nut (3), washer (2) and end fitting of the flexible coupling (1). Similarly apply a torque stripe across the bolt (6), washer (5) and the mounting point [Transmission input quill (11) or Existing engine adapter (7)]. Do not re-use previous mounting hardware.

- a. Disconnect battery.
- b. Remove inlet fairings and engine top cowling to gain access to the main driveshaft per the BHT Maintenance Manual.
- c. Remove and discard mounting hardware (Figure 1, items 2, 3, 5 and 6).

a. Measure the distance between the adapter face (Figure 1, item 7) and the input drive quill face (Figure 1, item 11). The distance must be 47.480 to 47.780 inches. If the distance is not met, adjust per the Bell maintenance manual. See Figure 2 for additional reference.

- b. Move the driveshaft into position between adapter face (Figure 1, item 7) and the input drive quill face (Figure 1, item 11).
 - i. Caution: Do not compress ends of driveshaft beyond 0.400". This will prevent damage.

- 1. Check general condition of KAflex Driveshaft.
 - a. Check for loose and missing hardware on the KAflex driveshaft (bolts, nuts, washers). If there is any loose or missing hardware on the KAflex driveshaft replace with a serviceable unit. Loose mounting hardware (Figure 1, items 2, 3, 5 and 6) are field serviceable by replacing with new hardware in accordance with this document.
 - b. Inspect flex frame and mount bolt torque stripes for evidence of slippage.

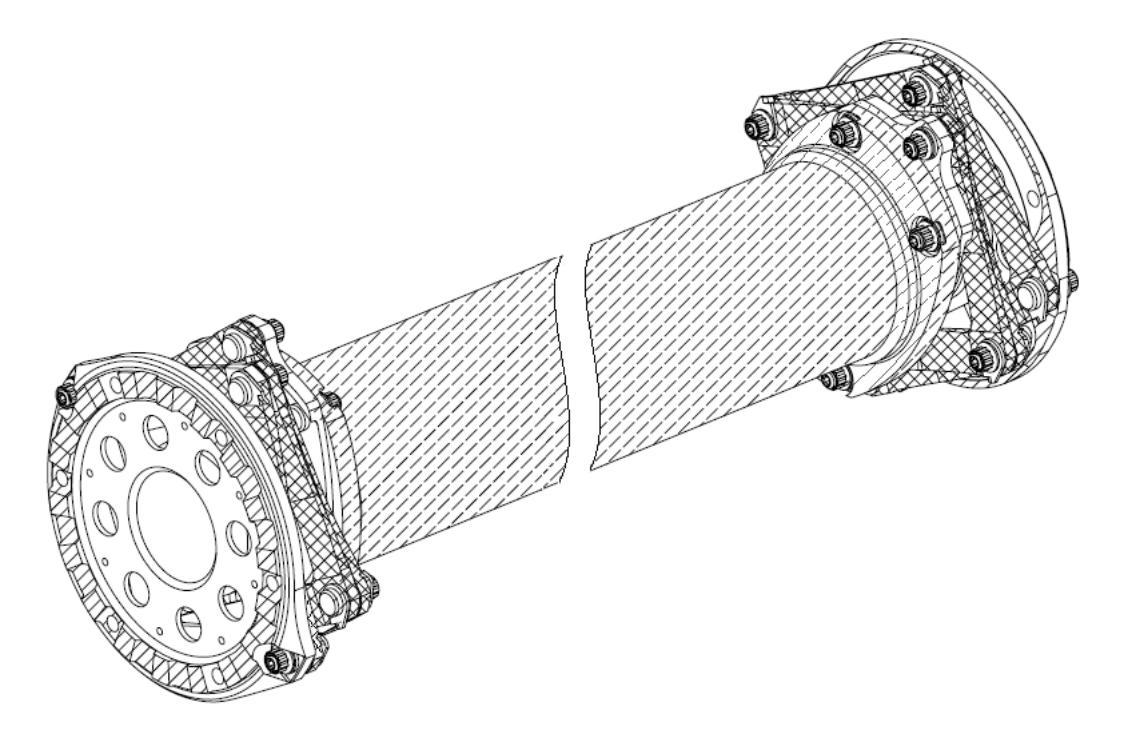
Figure 3, Damage and Repair Limits

Type of Damage	Maximum Damage and Repair Depth						
AREA							
MECHANICAL	0.001" before and	0.012" before and		0.015" before and			
	after repair	after repair		after repair			
CORROSION	Surface, no pits	0.012" before and after repair	2	0.010" before and after repair			
MAXIMUM AREA PER FULL DEPTH REPAIR SQ. IN.	0.05 in ²	0.09 in ²	0.25 in ²	0.25 in ²			
NUMBER OF REPAIRS	One per leg	10	3	One per 1 in ²			
EDGE DENTS, NICKS	0.001 in	\wedge	0.005 in	0.025 in			
CRACKS	None	None	None	None

- Do not repair indented damage on curvic teeth. Remove raised damage material with fine (150 grit) aluminum oxide or silicon carbide stone by hand polishing flush with surrounding surface. Repair not to exceed 25% of total tooth face. No more than 3 adjacent teeth or a total of 50% of all teeth.
- Repairs limited to damage that can be removed by hand polishing with fine abrasive pad (scotch brite) A-A-58054, type 1, class 1, grade A. Repairs limited to damage that can be removed by hand polishing

- 3. Repairs no less than 1.00 in APART and 0.50 in from bolt holes
- 4. Faying surface must be free from any raised metal areas.
- 5. All repairs to be 32 RMS, 0.25 in minimum radius.
- 6. Exposed bare metal may be touched up with aluminum ceramic coat Sermetel 1122.

- Nicks or scratches aligned within 30° of the spanwise axis are acceptable without repair to a maximum depth of 0.004 in.
 - 8. All repairs to be 32 RMS, 0.25 in minimum radius.
 - 9. If damage extends to bare metal, apply chemical film material (Alodine 1201), MIL-DTL-81706, FORM III, per NA 01-1A-509 series.
 - 10. Total area of all repairs not to exceed 10 in² with no two repairs within 2.00 in.
 - 11. All dimensions are in inches unless otherwise stated.

- d. Inspect KAflex Driveshaft for damage and corrosion. Refer to Figure 3 (in Section 7.0) for damage and repair limits.
- e. Inspect KAflex Driveshaft flex frame joints for fretting dust which will appear as red metallic residue. If grease, oil or dirt is covering suspected area, or any doubt exists as to whether actual fretting has occurred, clean suspected areas thoroughly and recheck in conjunction with next daily inspection.

- 1. Refer to Figure 3 for repair criteria. All blends shall be smooth at maximum depth and smoothly blended with surrounding surfaces.
- 2. The KAflex Driveshaft is not field overhauled. Disassembly of the KAflex driveshaft will render it unserviceable.
- 3. The KAflex Driveshaft is to be removed at 5,000 hours and replaced with a serviceable unit.
